Safety Alert – Purity of N2 supply

The incident involved a pulsation dampener on a high pressure mud pump, exploding catastrophically.

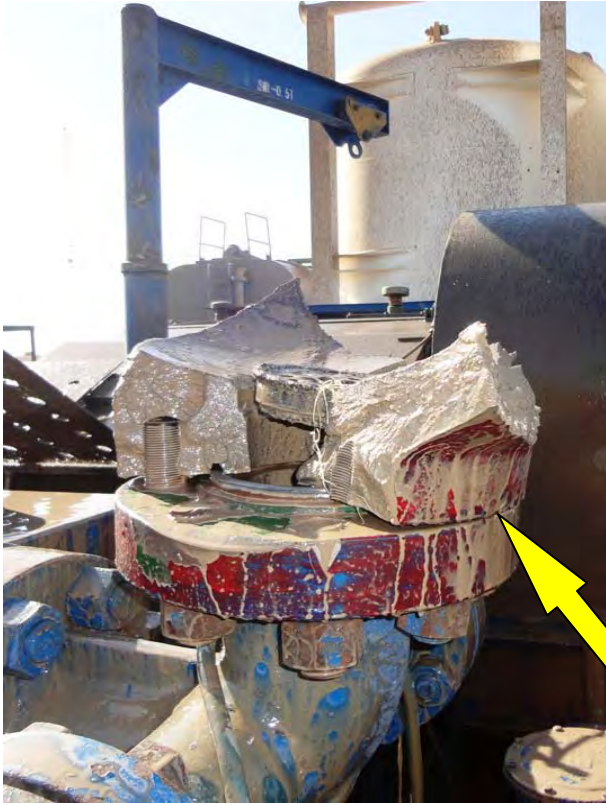
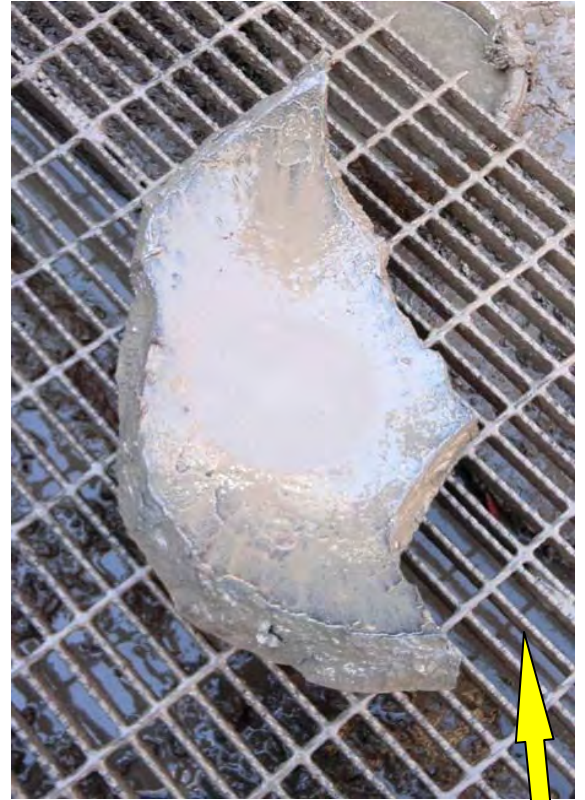
Close up view of the exploded Pulsation dampener – wall thickness of this material is 8 cm's plus – Pressure Rating approximately 5000 psi.

One of the “bomb” fragments

Preliminary investigation has identified that the source bottle of Nitrogen that had been used to precharge this Pulsation dampener, had more than 20% oxygen. Weakly emulsified diesel oil in the mud, may have phase-separated, and accumulated under the diaphragm/bladder. If oil under pressure in a closed system, can mix with oxygen and explosion can take place.

Post accident investigation analysis indicated the diaphragm material was in poor condition.

1. Develop a system to inspect nitrogen bottles on the rig to ensure no other gases are present.
2. Develop a procedure to check all nitrogen cylinders upon being received at the work site and before placing in use.
3. Adopt an international standardized color code system for all gas cylinders used [such as BS 349].
4. Develop a program to require testing and documentation of all nitrogen cylinders contents at rig site.
5. Standardize valves used for nitrogen to be different from other valves used in other gas cylinders.
6. work on energized systems should be performed under PTW, under which the potential hazard of O2 being present in N2 bottles is identified and the mitigation controls are specified. .

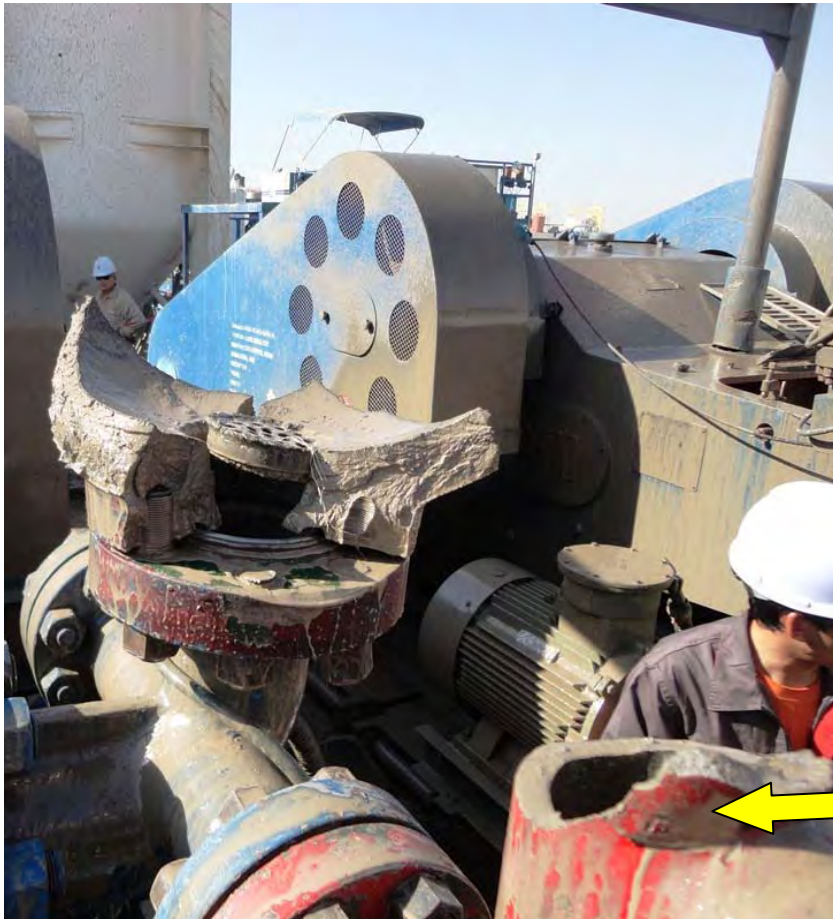
It is also possible to see the explosive power, which destroyed an adjacent “Pop” valve line, wall thickness 1.5 cm's

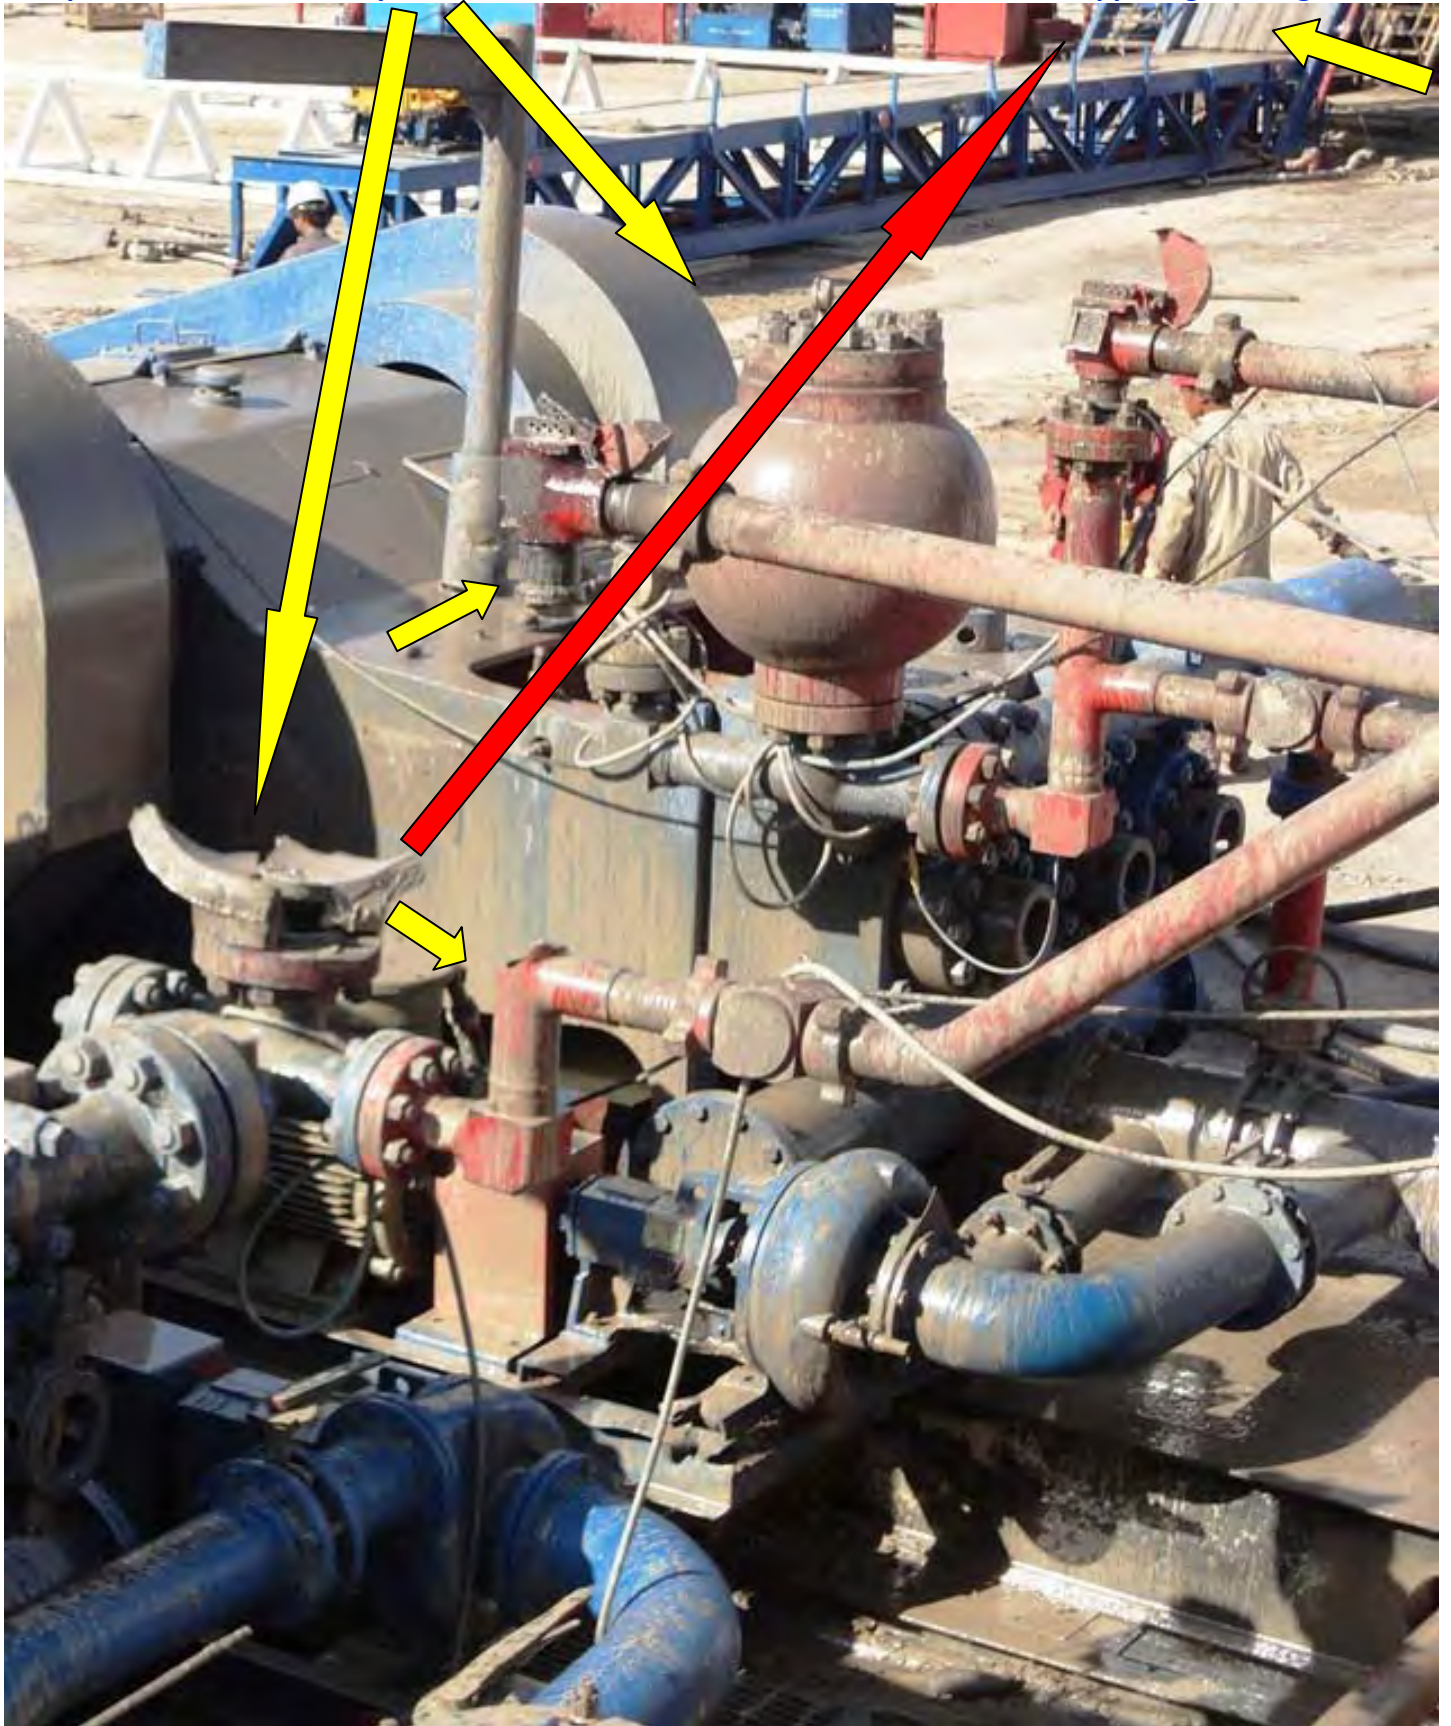
Below, it is possible to see the normal Pulsation Dampener, as well as the exploded one.

Again it is also possible to see the explosive power, which destroyed an adjacent "Pop" valve line, wall thickness 1.5 cm's

Red arrow indicates possible direction of one exploded fragment, toward the derrick tower, with stands of drill pipe, as well as the V Door/catwalk stairs on which at least eight stair steps were destroyed.

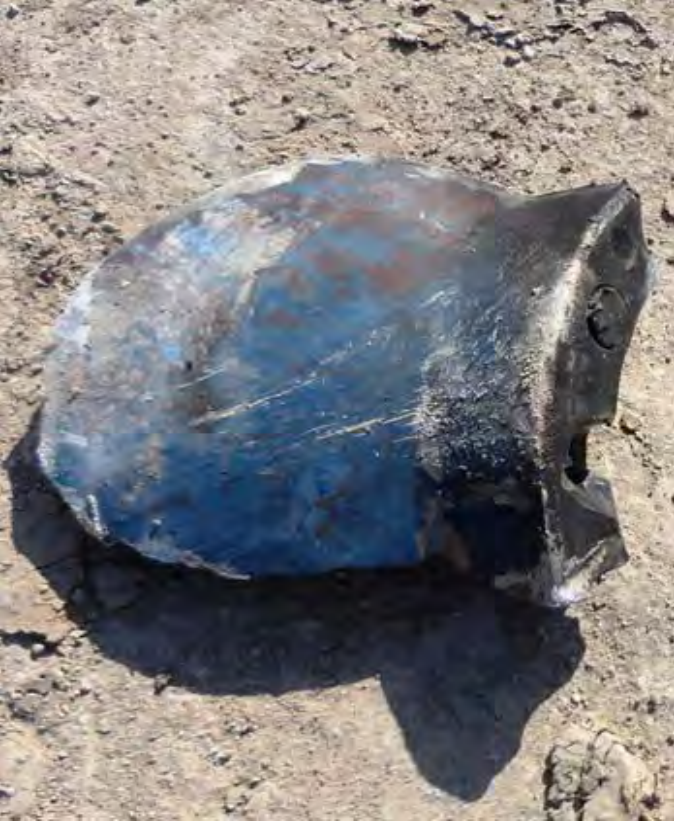
This may be the fragment that went toward the rig monkey board, hitting two stands of pipe 8 meters above the rig floor [15+ meters above the pump]

Two stands of drill pipe damaged from the velocity and energy of the impact.

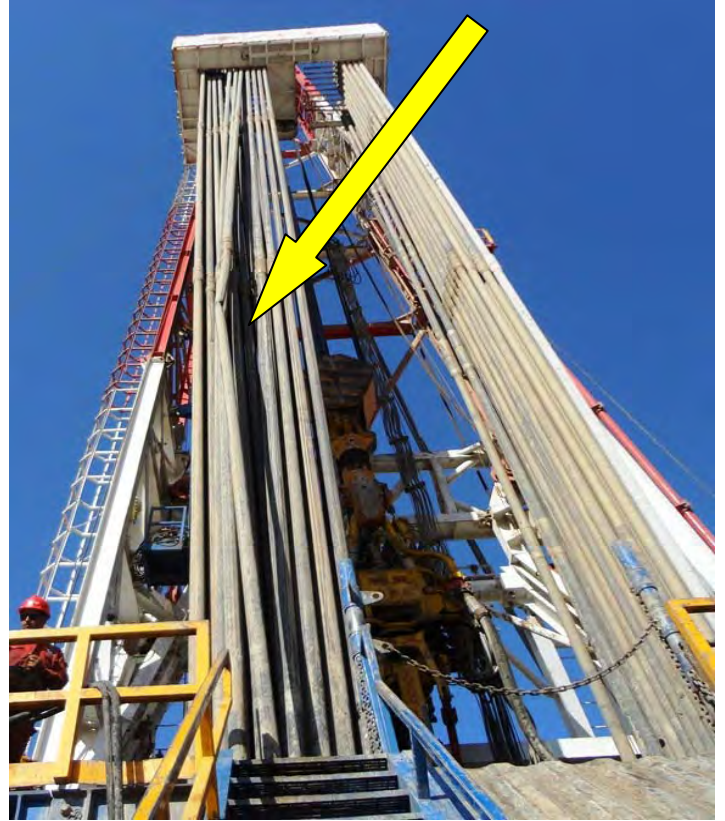
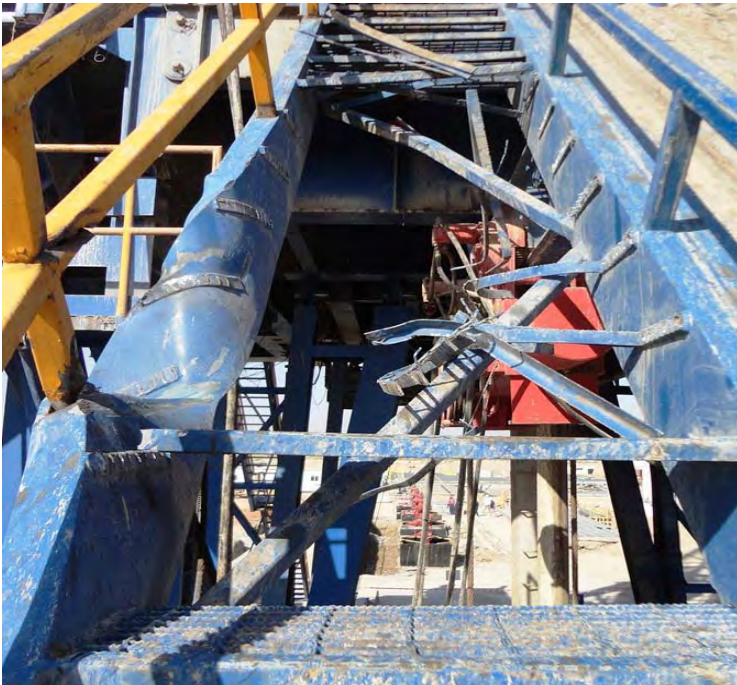
Catwalk Stairs damaged by flying fragment of Pulsation Dampener

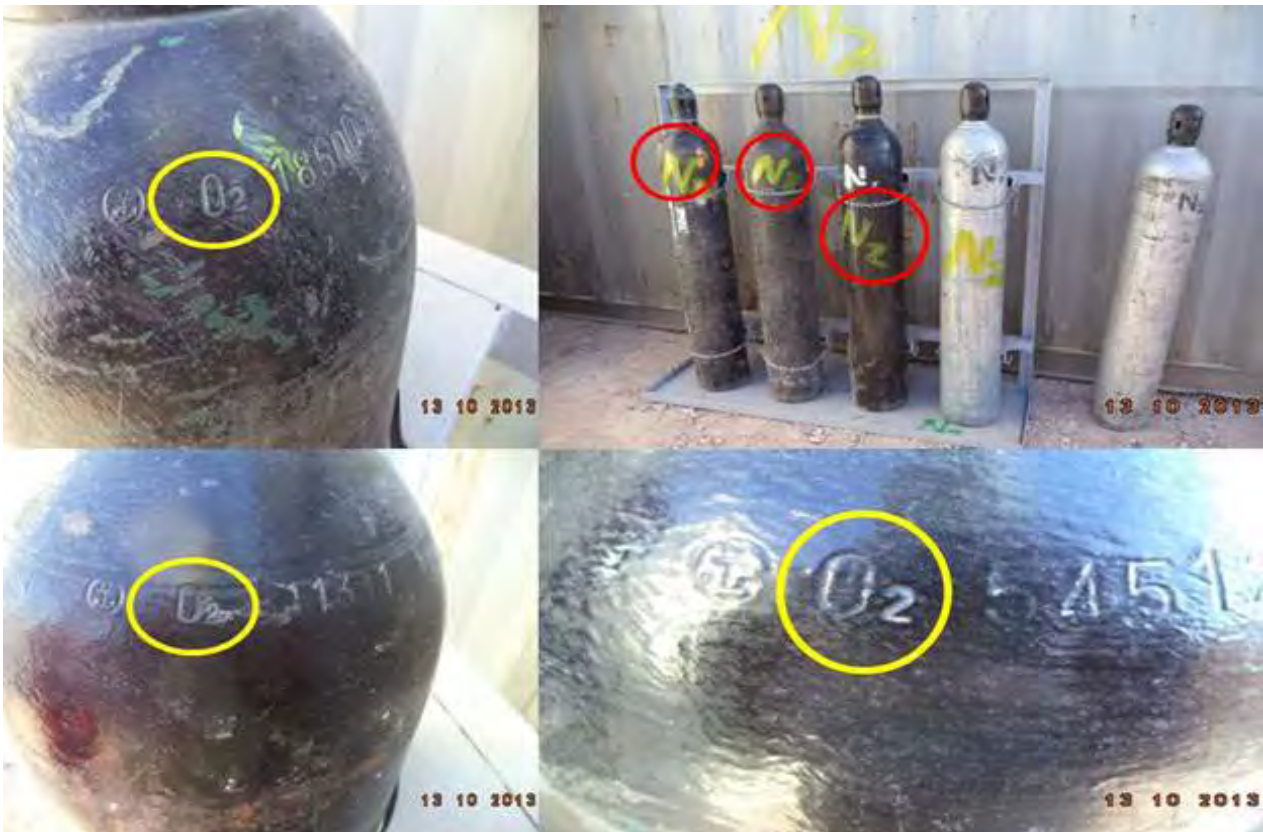
The 3 black bottles - manufactured and identified as to gas type according to BS 349 standard – have been filled locally with N₂. Grey bottles to the side in upper right corner are colored and stenciled correctly for N₂.

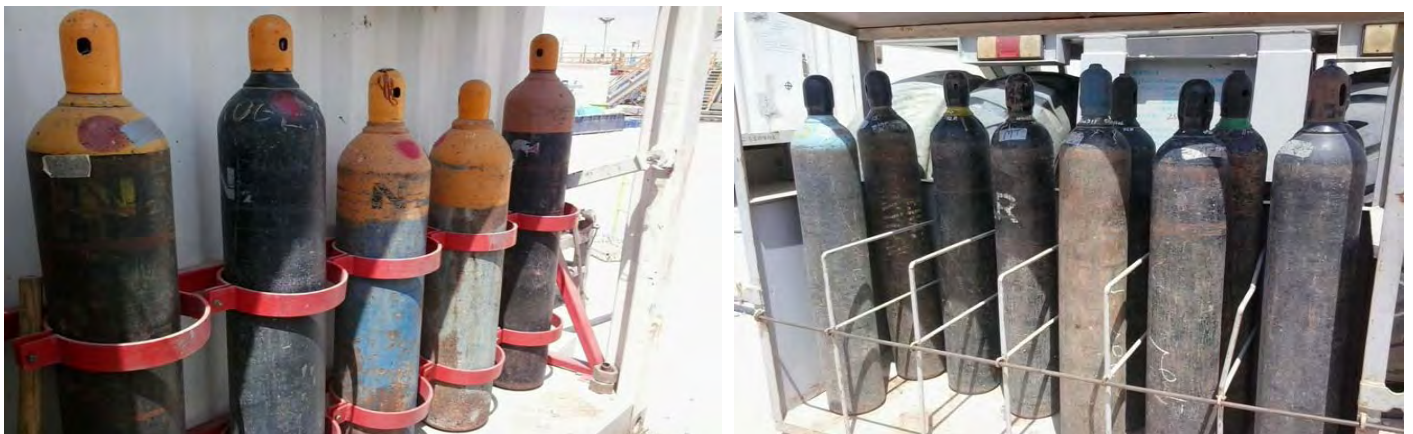
More examples of the variety of color cylinders available for pressurized gases.

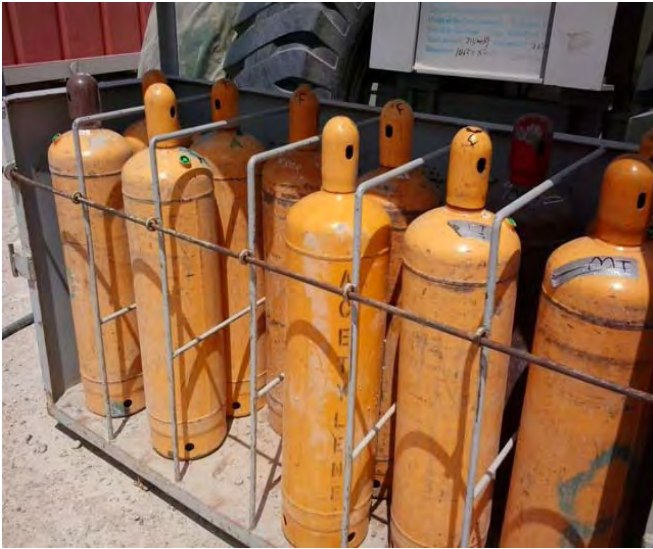
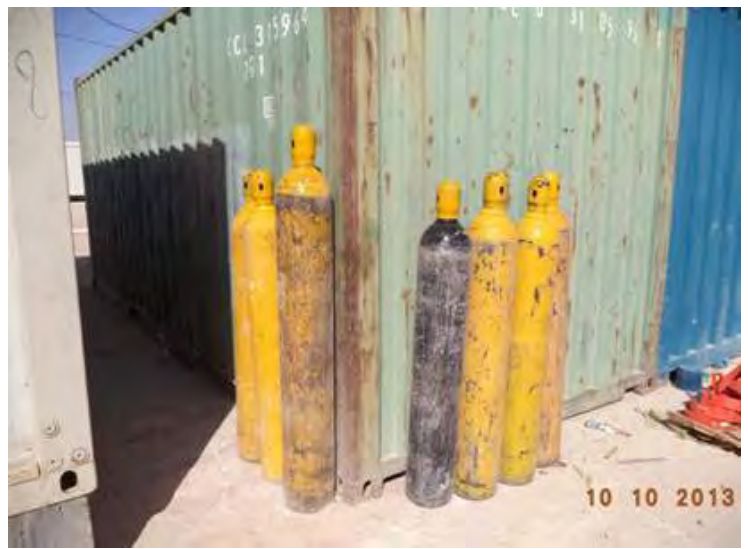
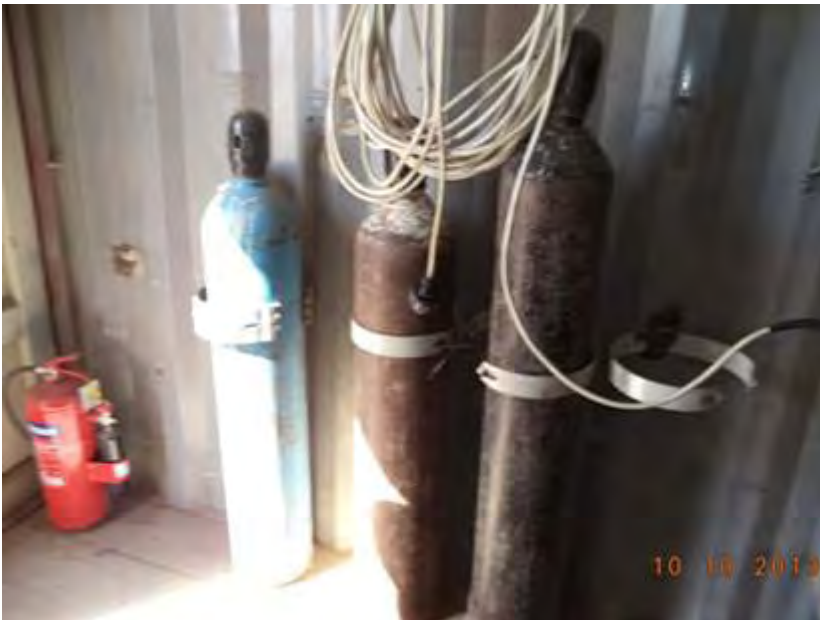
Oxygen Cylinders with two different colored code!!!!!!!!!!

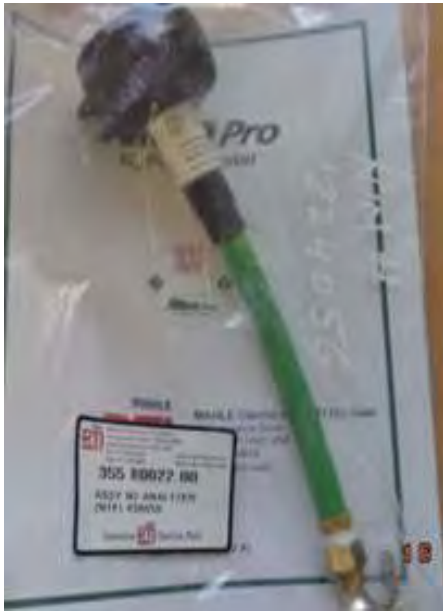
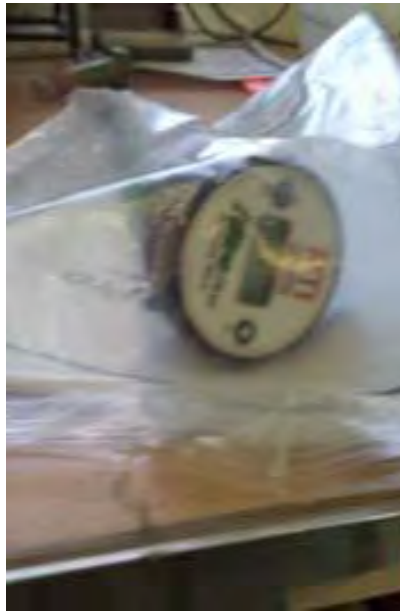
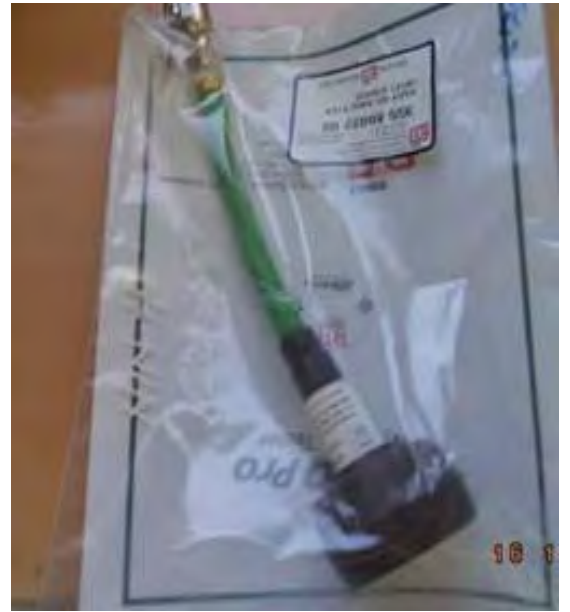
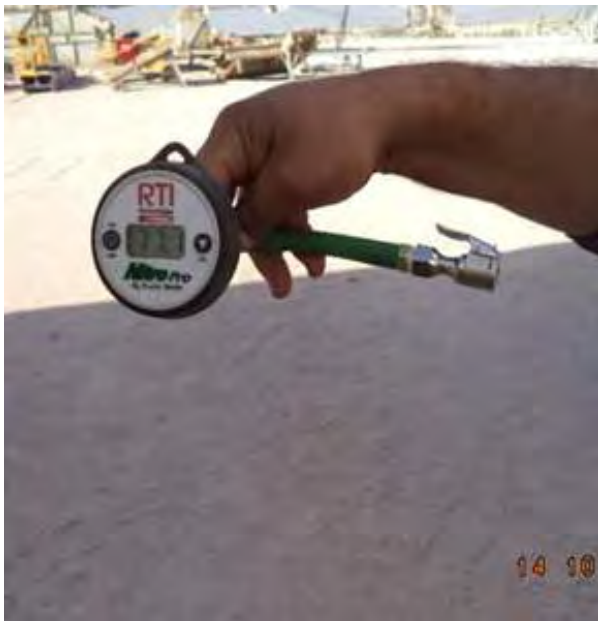
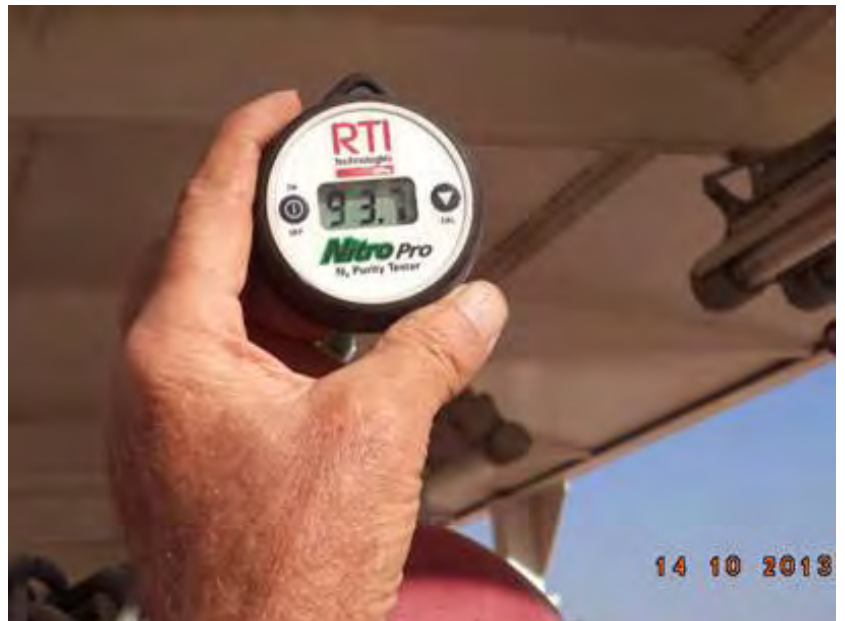
Recently rig F-17 introduced a new method to verify the gas bottle content .

The best method is by using N2 purity tester to verify the gas bottle content accurately
